Navajo Abandoned Uranium Mine

Site Screen Report

Charles Huskon No. 4 AUM Site

January 2011

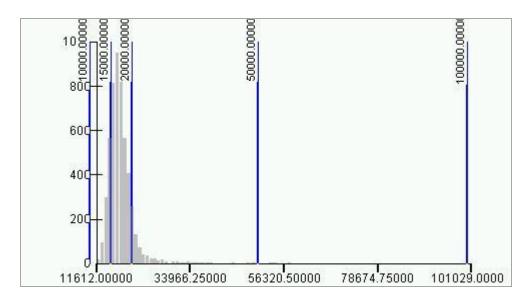
The following chart and statistics were generated by ESRI ArcGIS 9.3.1, and show the general distribution of the site gamma radiation measurements. The horizontal X axis represents the gamma radiation reading levels in cpm (lowest levels to the left). The vertical Y axis represents the frequency of each gamma radiation level.

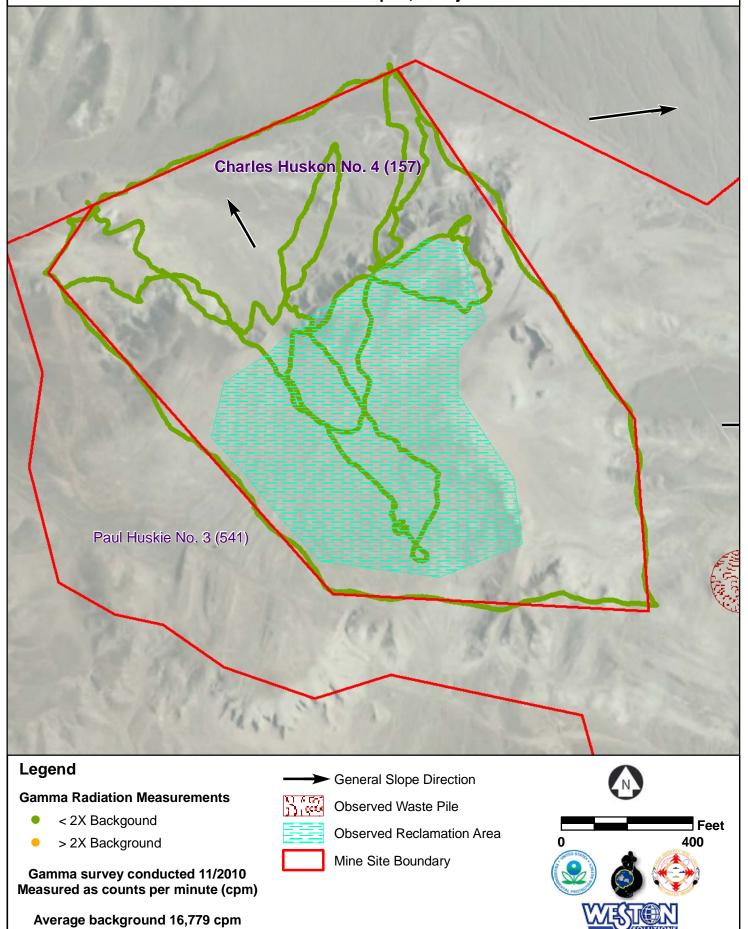
Figure 1 - Gamma Radiation Measurements, Above Two Times Background
Charles Huskon No. 4 (157)
Coalmine Mesa Chapter, Navajo Nation

A total of 5,288 gamma radiation measurements were collected from the mine site, ranging from 11,612 cpm to 101,029 cpm. The measurements are represented in Figures 1 and 2.

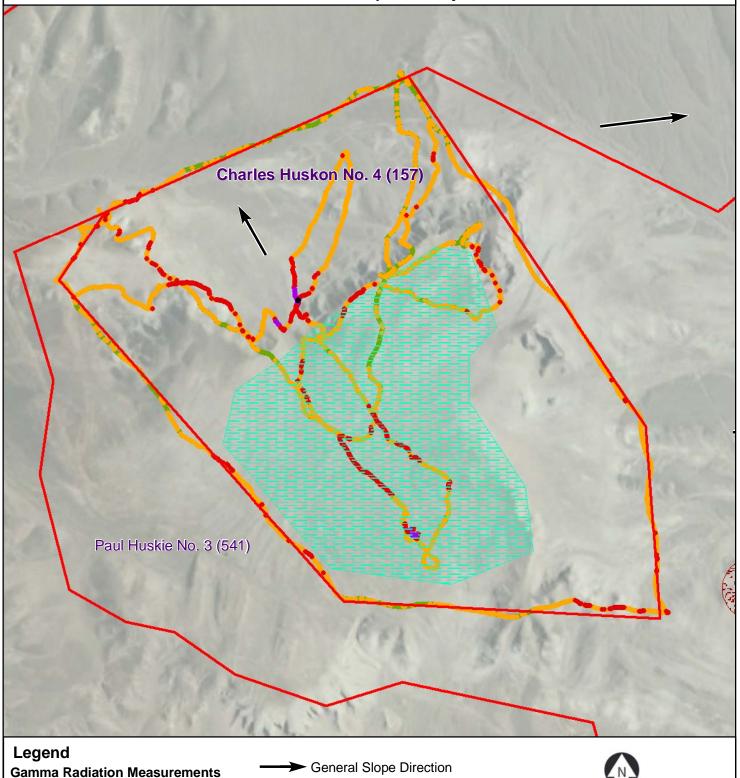
Figure 2 - Gamma Radiation Measurements Charles Huskon No. 4 (157) Coalmine Mesa Chapter, Navajo Nation

Gamma survey conducted 11/2010 Measured as counts per minute (cpm)

Average background 16,779 cpm
